THE 43TH TURBO MACHINERY SYMPOSIUM CASE STUDY

CGC LARGE STEAM TURBINE VIBRATION RESONANCE OF PEDESTAL
AND LINKAGE SYSTEM RCA, DETAIL VIBRATION
INVESTIGATION/MEASUREMENT AT SITE AND COUNTERMEASURES

Makoto Katagake

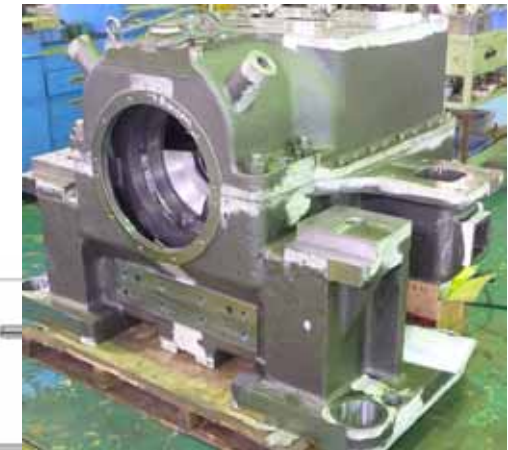
New casting type

Integration between pedestal and casing support

Robust support

Casting pedestal type has more high stiffness than current fabricated type

- 1) Applicable full contact condition of pedestal surface.
- 2) Rigidly connection between pedestal body and casing support without freestanding.

Existing pedestal & cover	New pedestal & cover
Carbon steel SS400 (Eq. ASTM A36)	Cast steel SC450 (Eq. ASTM27-93 Gr65)
Pedestal : 1590 kg	Pedestal : 1880 kg

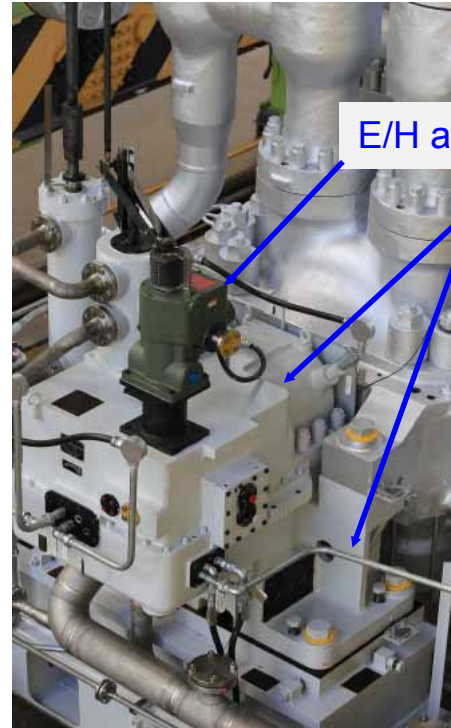
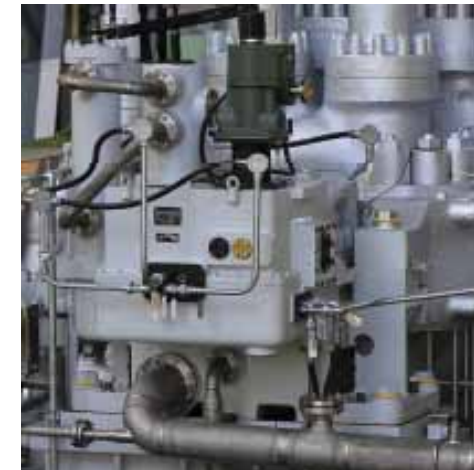
Outline of application to similar 9EH turbine

Governing valve

E/H actuator with linkage

Improved pedestal, cover
